KOPPERS PETROLIA PLANT
No. 3 RESERVOIR DAM

NDI No. PA 00902
PennDER No. 10-74

PHASE I INSPECTION REPORT
NATIONAL DAM INSPECTION PROGRAM

Koppers Petrolia Plant - No. 3 Reservoir Dam
Butler County, Pennsylvania
NDI No. PA 00902, PennDER No. 10-74
Unnamed Tributary to the South Branch of Bear Creek
Inspected 17 May 1979

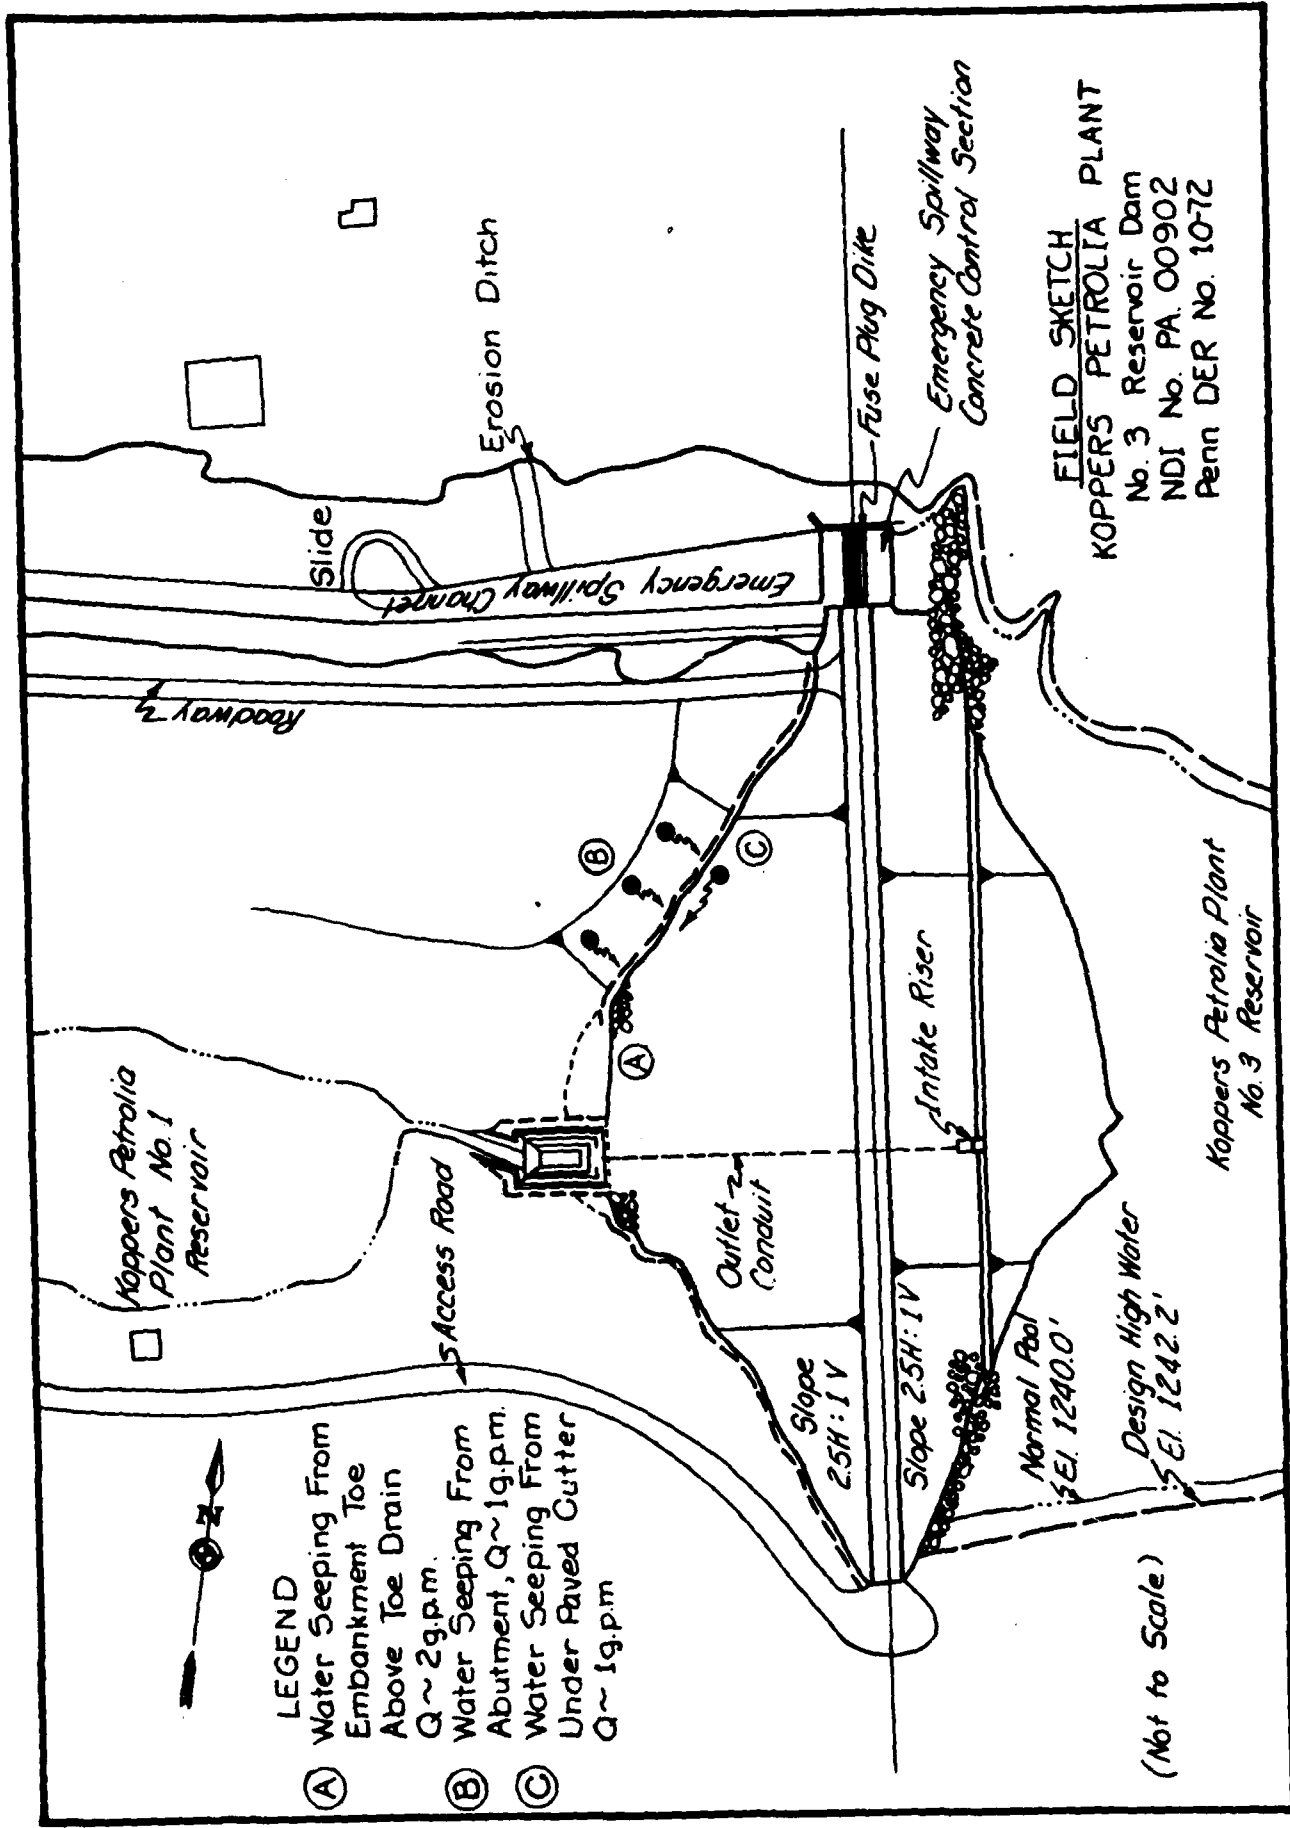
- (A) Water Seeping From Embankment Toe Above Toe Drain Q ~ 2g.p.m.
- (B) Water Seeping From Abutment, Q ~ 1g.p.m.
- (C) Water Seeping From Under Paved Cutter Q ~ 1g.p.m.
